# General Service Bulletin

YC-SB-10A

**SUBJECT:** Two (2) Speed Combustion Blower Motor Failures on Mid-Range Voyager Gas/Electrics

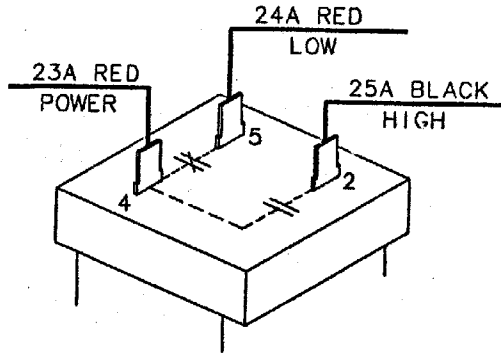
EXISTING WIRING ARRANGEMENT

6.25 - 7.50 TON UNITS

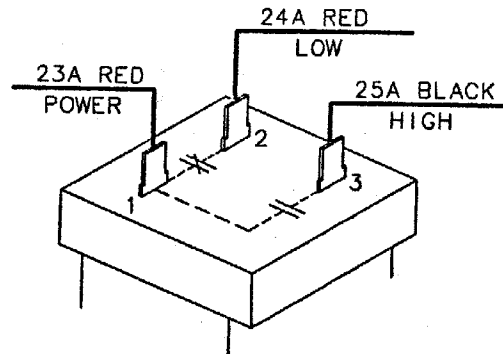
EXISTING WIRING ARRANGEMENT

8.5 - 20.0 TON UNITS
